*C*Limited Metallurgical Examination

C.1 Introduction

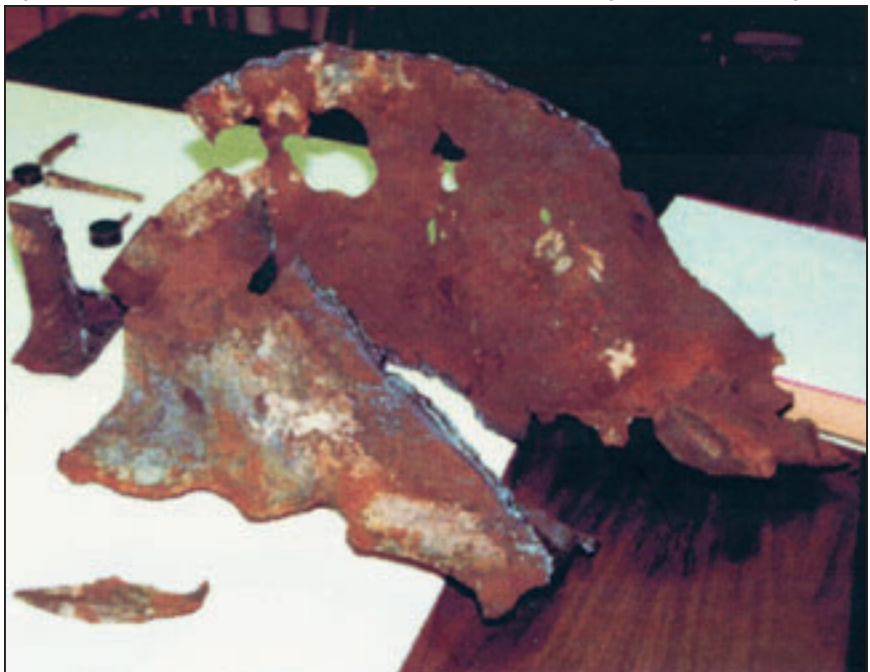
Several regions in the section of the beam shown in Figures C-1 and C-2 were examined to determine microstructural changes that occurred in the A36 structural steel as a result of the events of September 11, 2001, and the subsequent fires. Although the exact location of this beam in the building was not known, the severe erosion found in several beams warranted further consideration. In this preliminary study, optical and scanning electron metallography techniques were used to examine the most severely eroded regions as exemplified in the metallurgical mount shown in Figure C-3. Evidence of a severe high temperature corrosion attack on the steel, including oxidation and sulfidation with subsequent intergranular melting, was readily visible in the near-surface microstructure. A liquid eutectic mixture containing primarily iron, oxygen, and sulfur formed during this hot corrosion attack on the steel. This sulfur-rich liquid penetrated preferentially down grain boundaries of the steel, severely weakening the beam and making it susceptible to erosion. The eutectic temperature for this mixture strongly suggests that the temperatures in this region of the steel beam approached 1,000 °C (1,800 °F), which is substantially lower than would be expected for melting this steel.

Figure C-1 Eroded A36 wide-flange beam.

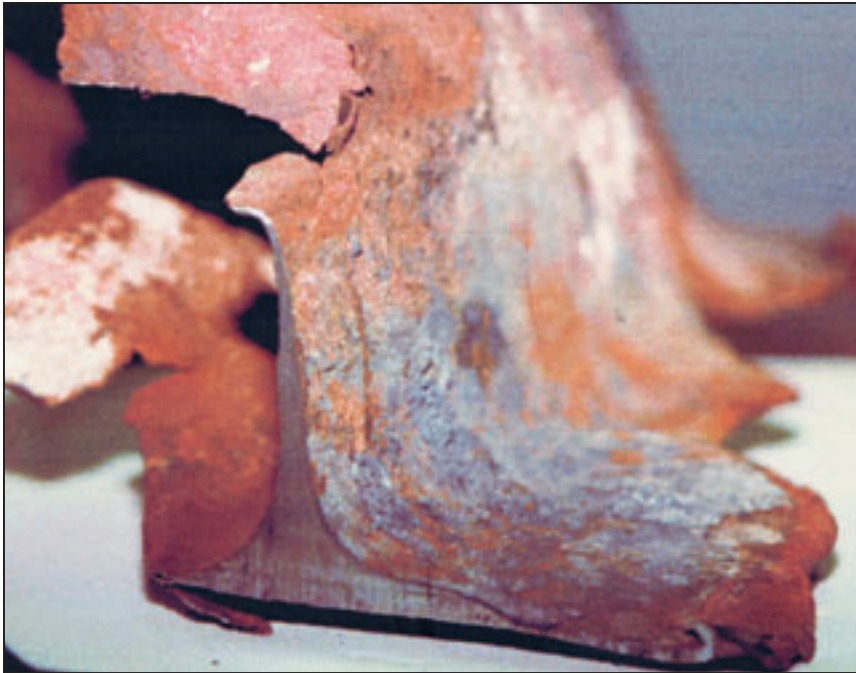
Figure C-2
Closeup view of eroded wide-flange beam section.

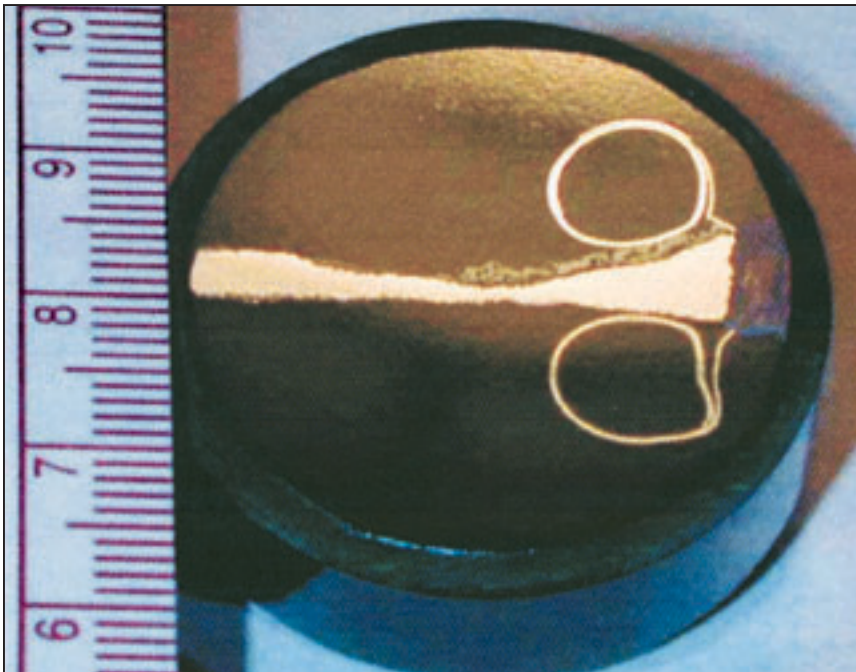
Figure C-3
Mounted and polished severely thinned section removed from the wide-flange beam shown in Figure C-1.

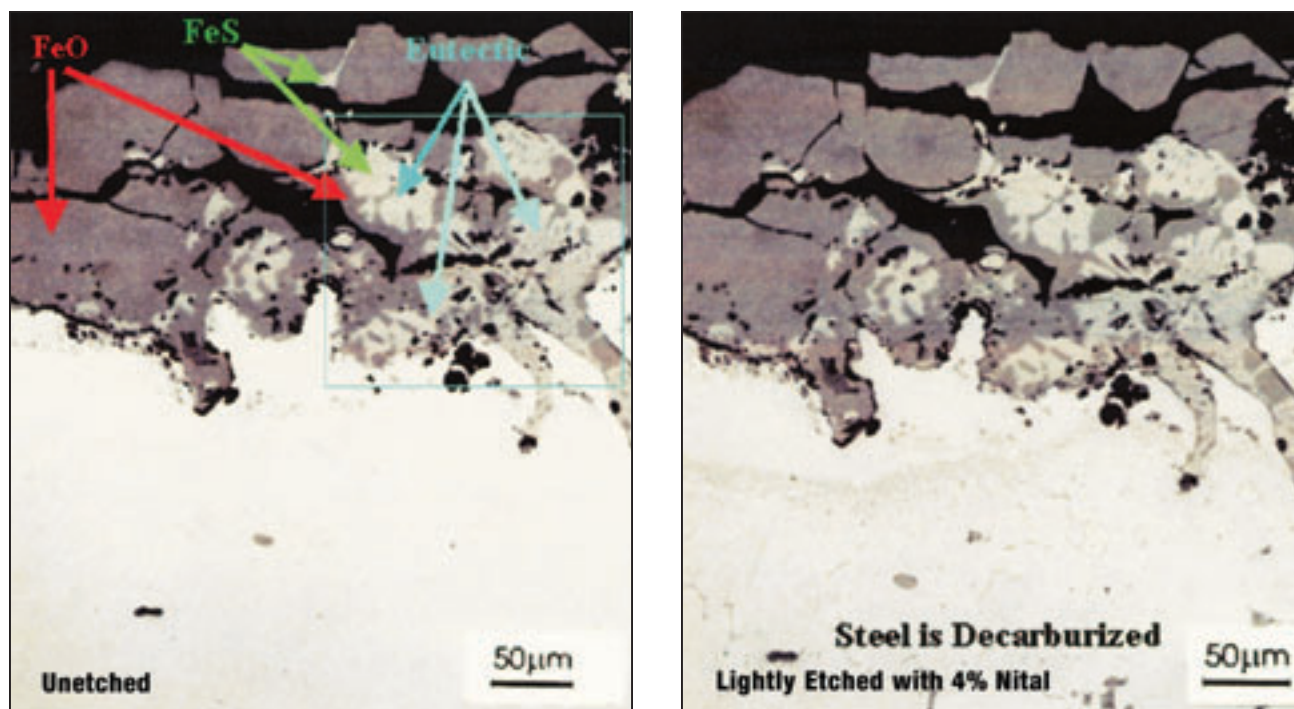
Figure C-4 Optical microstructure near the steel surface.

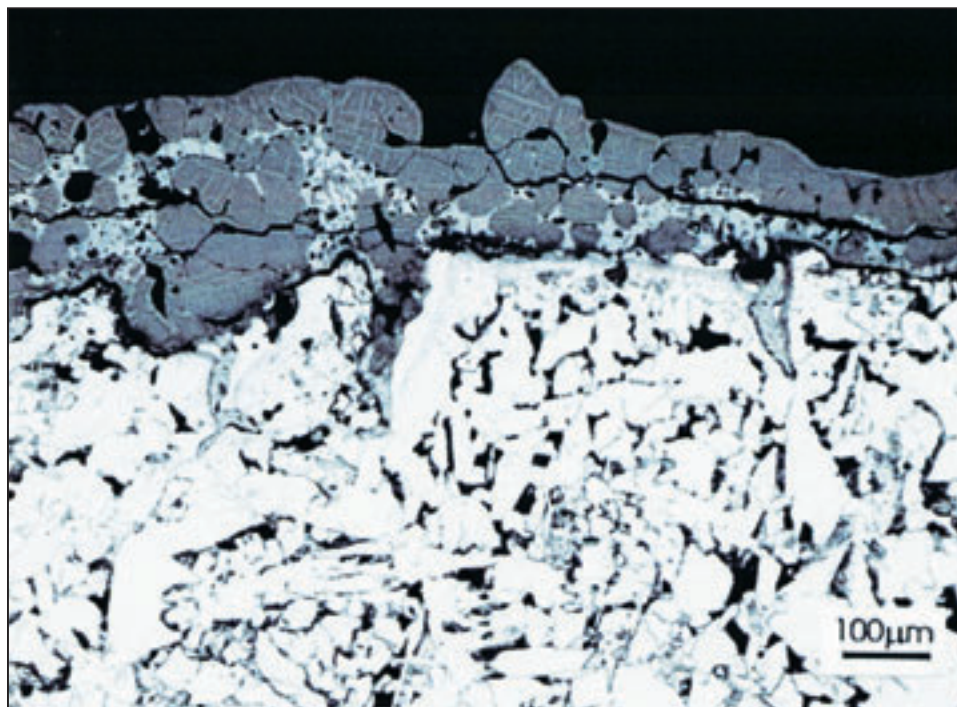
Figure C-5 Another hot corrosion region near the steel surface (etched with 4 percent nital). (Note: (1) Oxide rounding where the FeO-FeS eutectic product is present. (2) Reduction in banding of the steel when re-transformation occurs on cooling from austenite to ferrite and pearlite.)

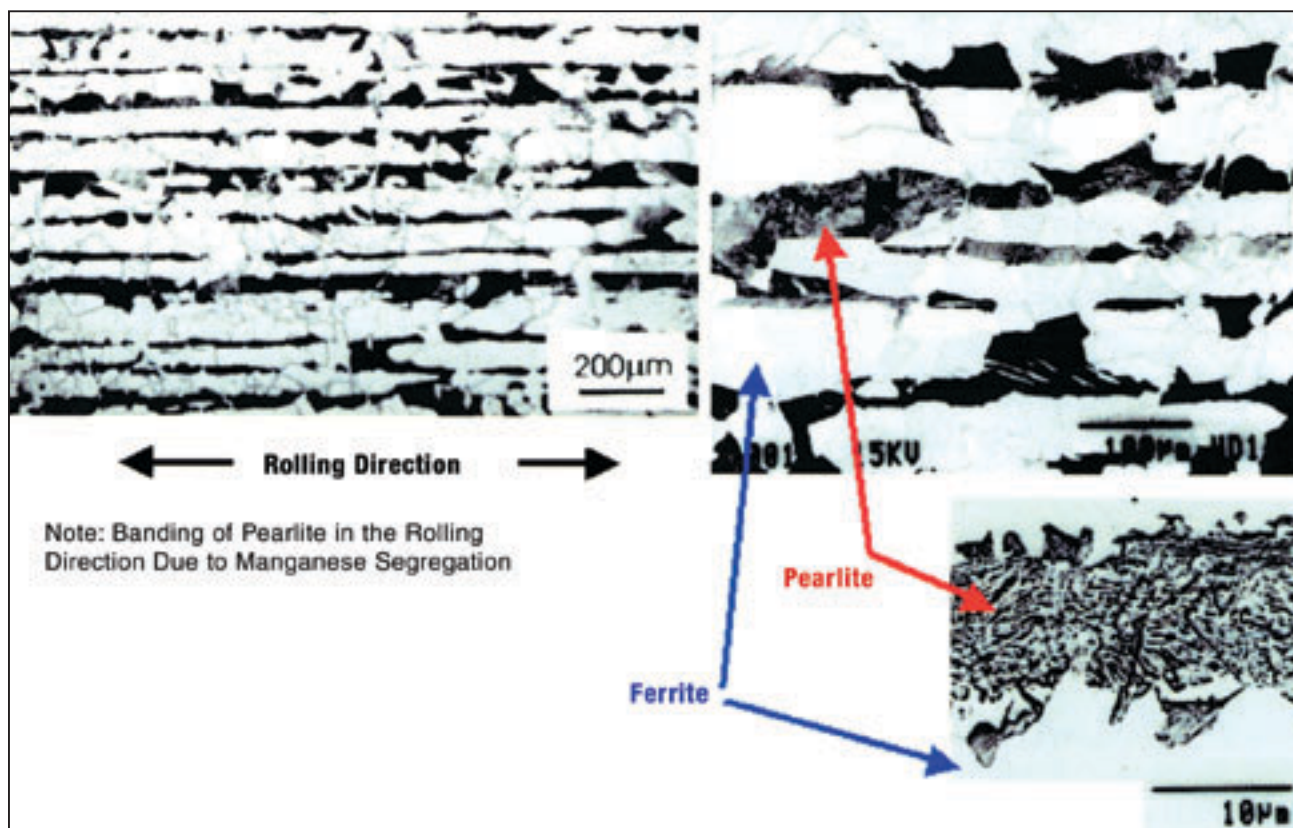
Figure C-6 Microstructure of A36 steel.

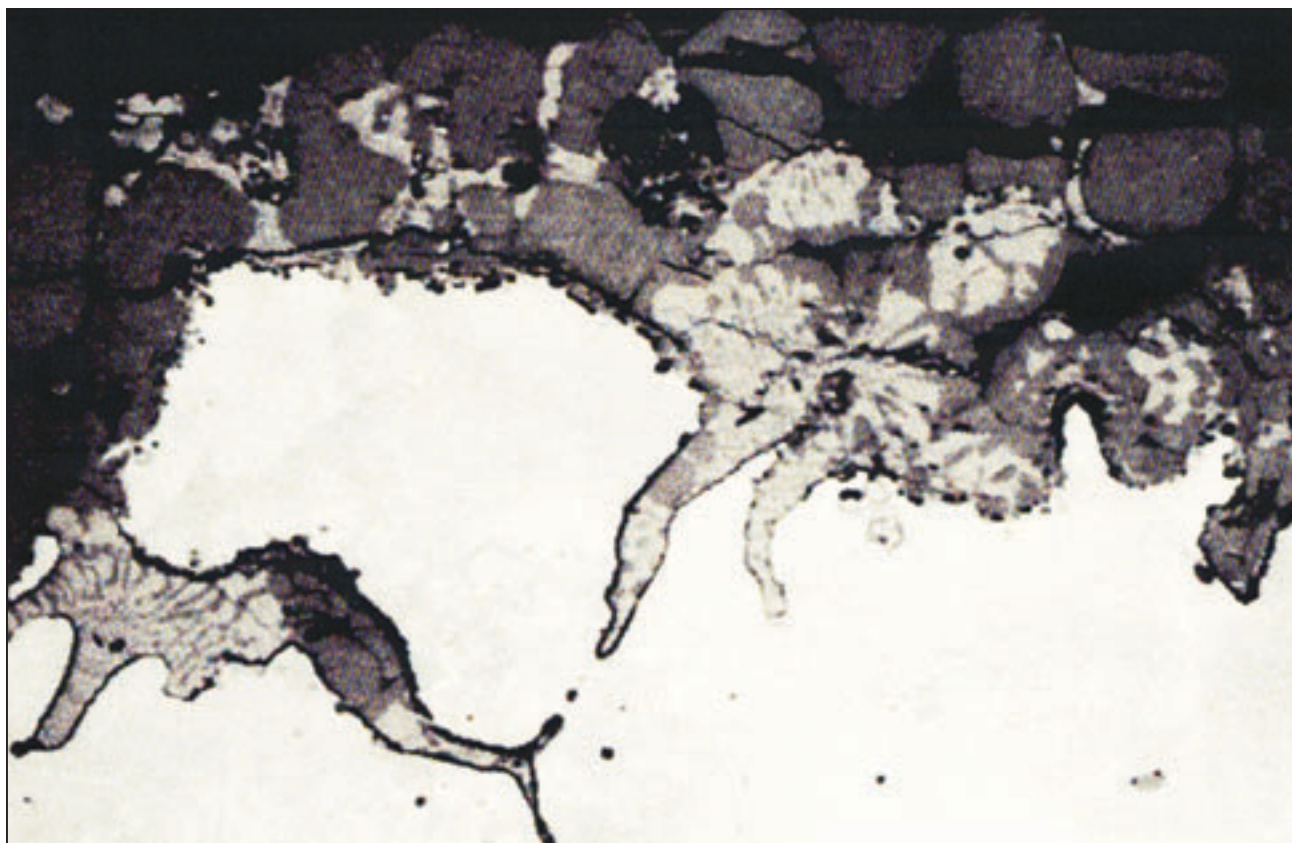
Figure C-7 Deep penetration of liquid into the steel. (Note: Hot corrosion of the steel can produce "islands" of steel surrounded by liquid, which will make erosion of the steel much easier.)

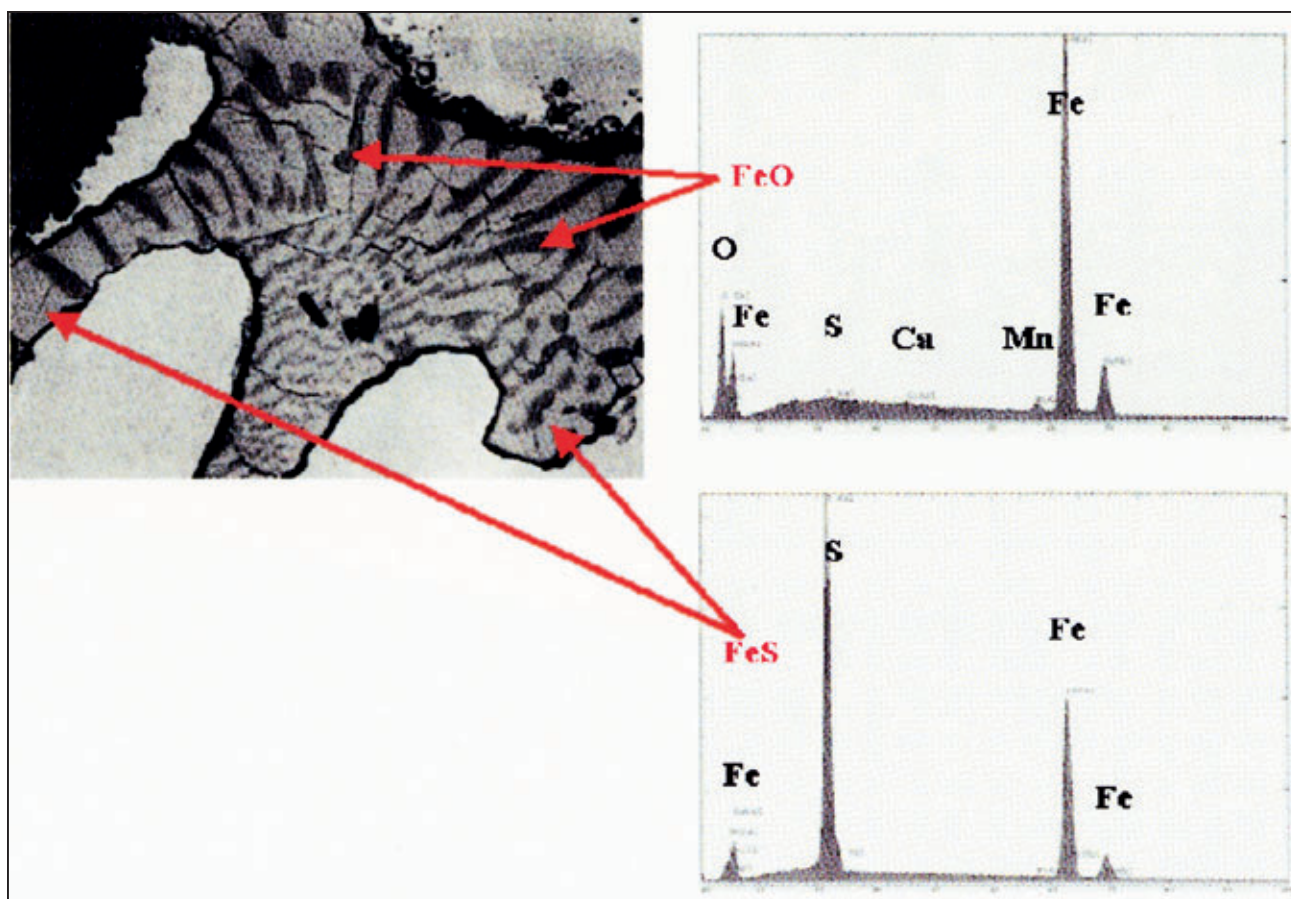
When steel cools below the eutectic temperature, the liquid of eutectic composition transforms to two phases, iron oxide, FeO , and iron sulfide, FeS . The product of this eutectic reaction is a characteristic geometrical arrangement that is unique and is readily visible even in the unetched microstructure of the steel. Figures C-4 and C-5 present typical near-surface regions showing the microstructural changes that occur due to this corrosion attack. Figure C-6 presents the microstructure from the center of a much thicker section of the steel that is unaffected by the hot corrosion. Figure C-7 illustrates the deep penetration of the liquid into the steel's structure. In order to identify the chemical composition of the eutectic, a qualitative chemical evaluation was done using energy dispersive X-ray analysis (EDX) of the eutectic reaction products. Figure C-8 illustrates the results of this analysis.

Figure C-8 Qualitative chemical analysis.

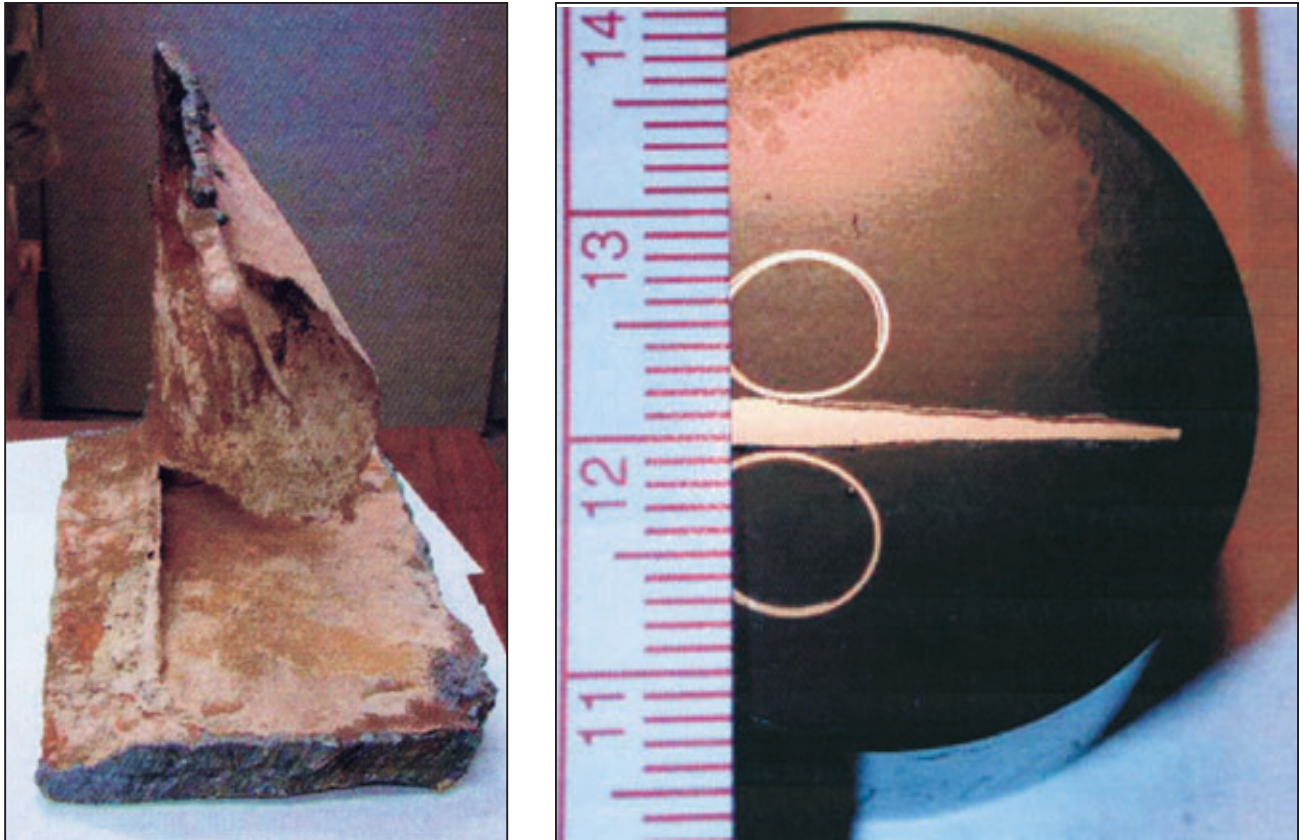
The origin of the steel shown in Figure C-9 is thought to be a high-yield-strength steel removed from a column member. The steel is a high-strength low-alloy (HSLA) steel containing copper. The unusual thinning of the member is most likely due to an attack of the steel by grain boundary penetration of sulfur forming sulfides that contain both iron and copper. Figures C-10, C-11, and C-12 show the region of severe corrosion at different levels of magnification.

Figure C-9 Qualitative chemical analysis.

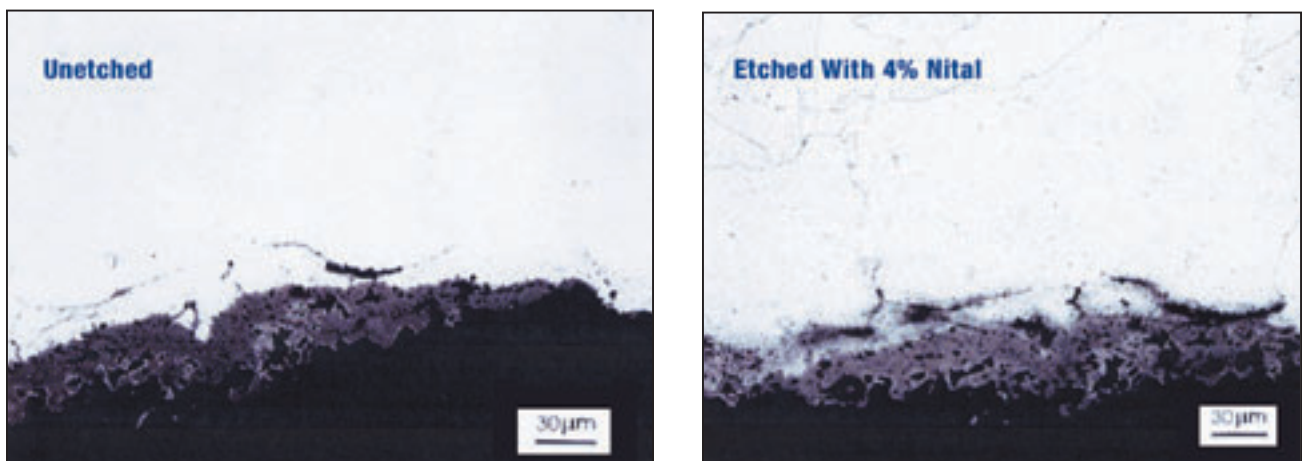
Figure C-10 Grain boundary corrosion attack.

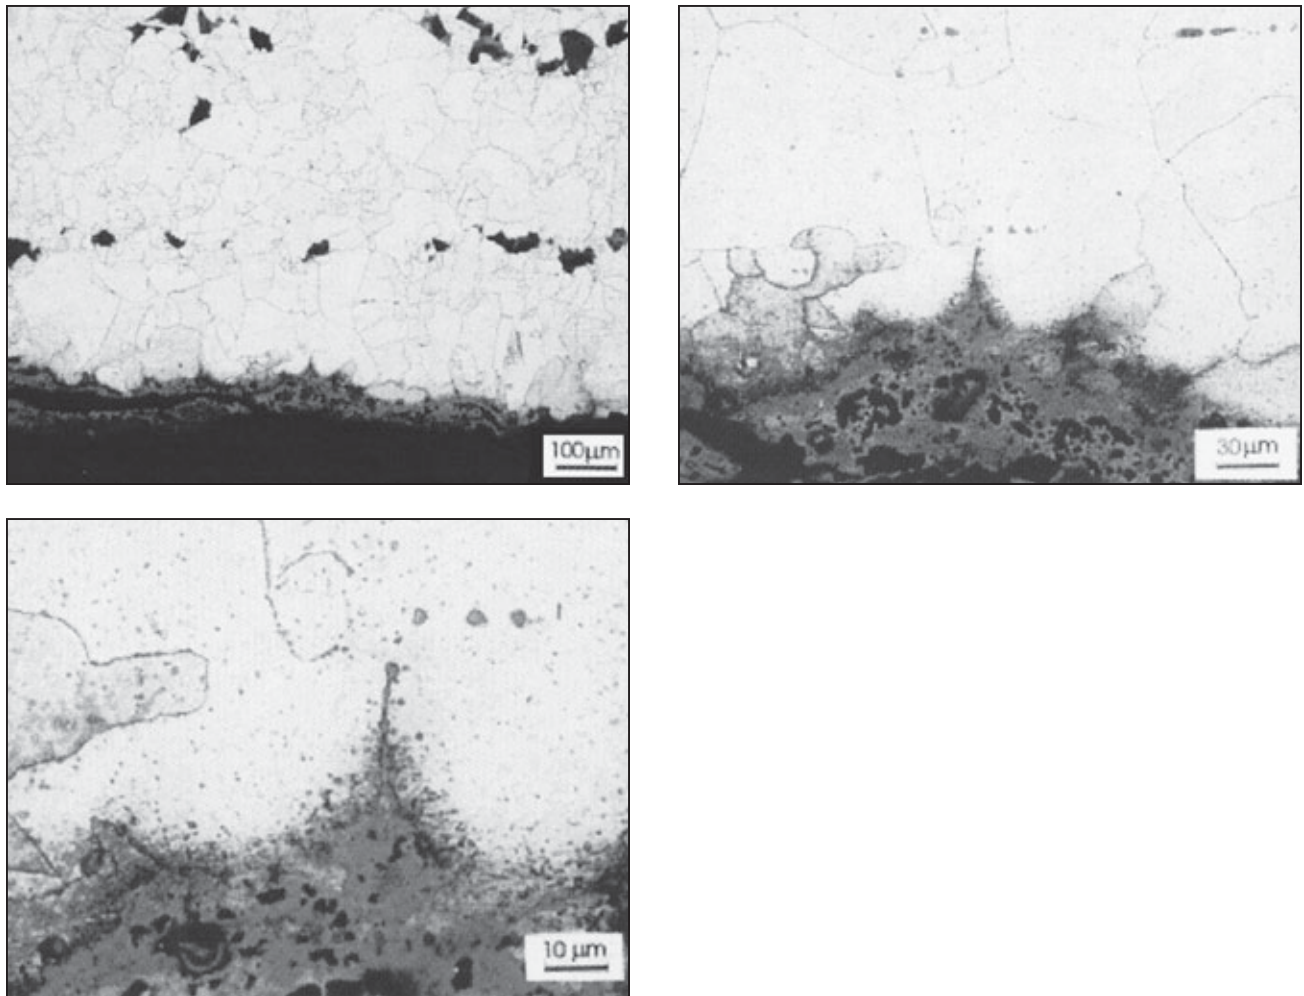
Figure C-11 Microstructure of a typical region showing the surface and grain boundary corrosion attack of Sample 2.

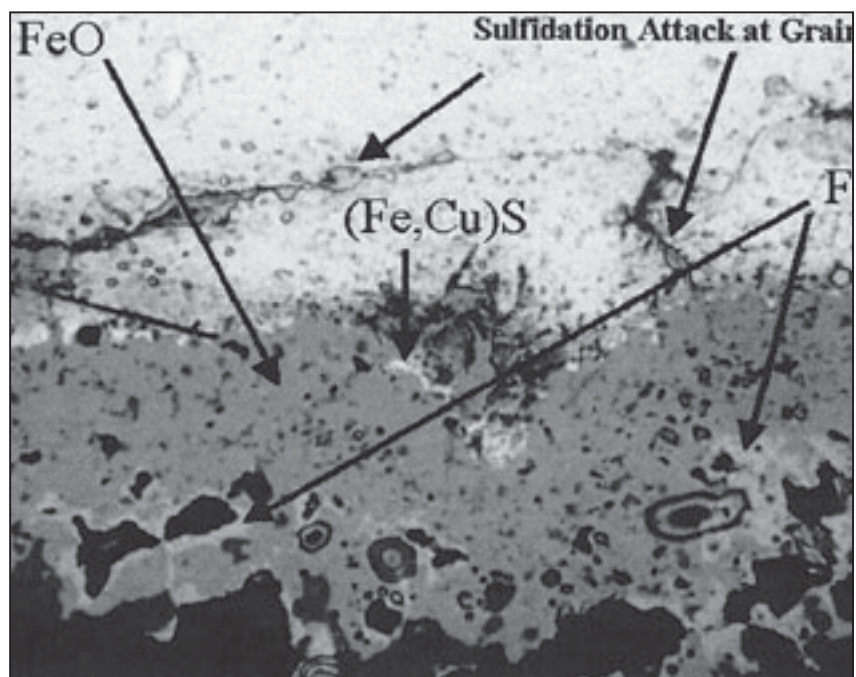
Figure C-12
Higher magnification of the region
shown in Figure C-10.

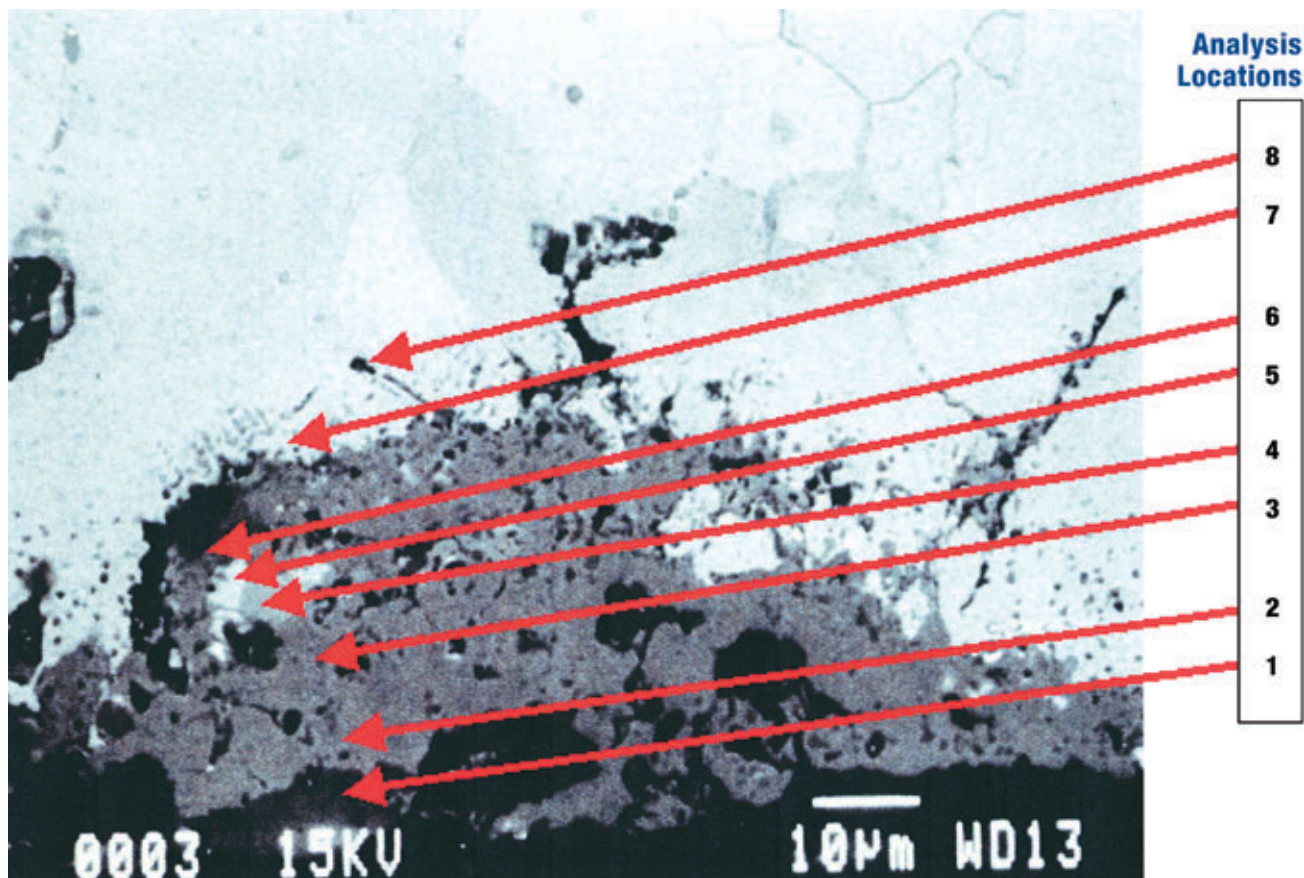
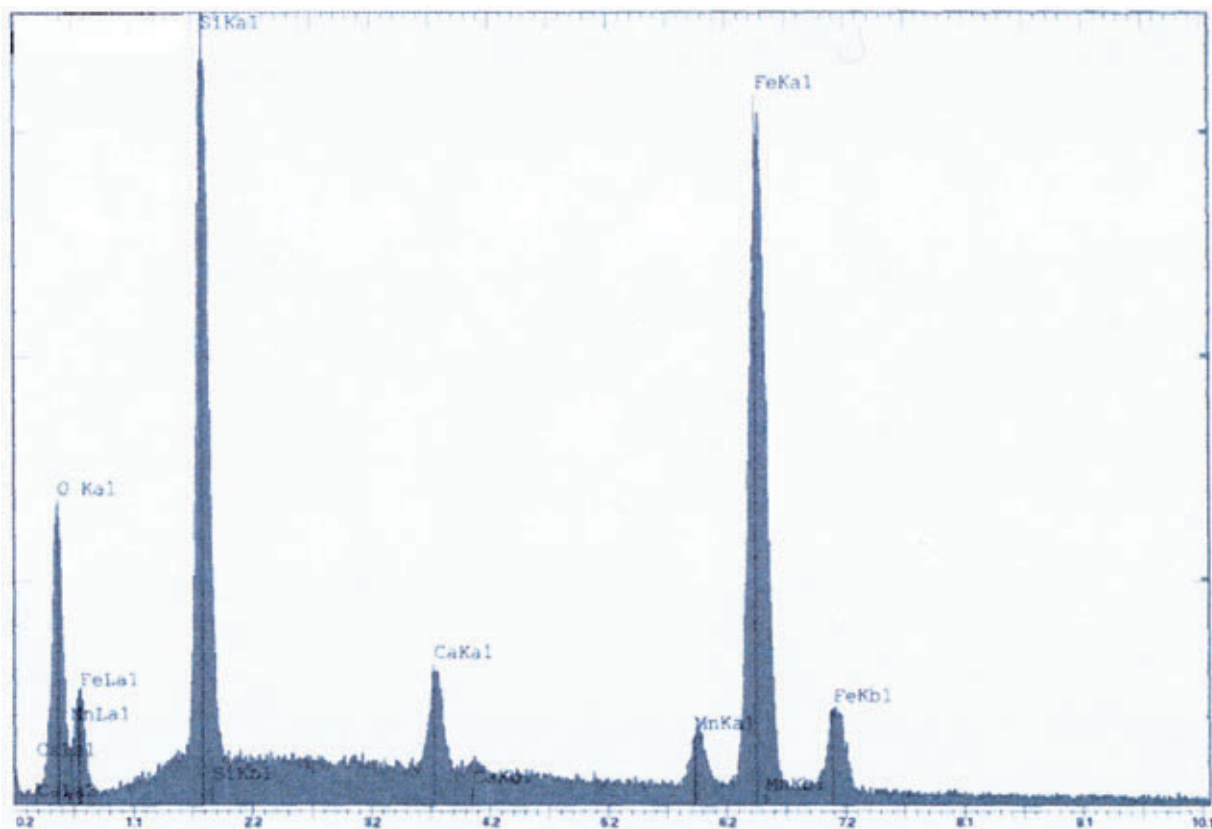
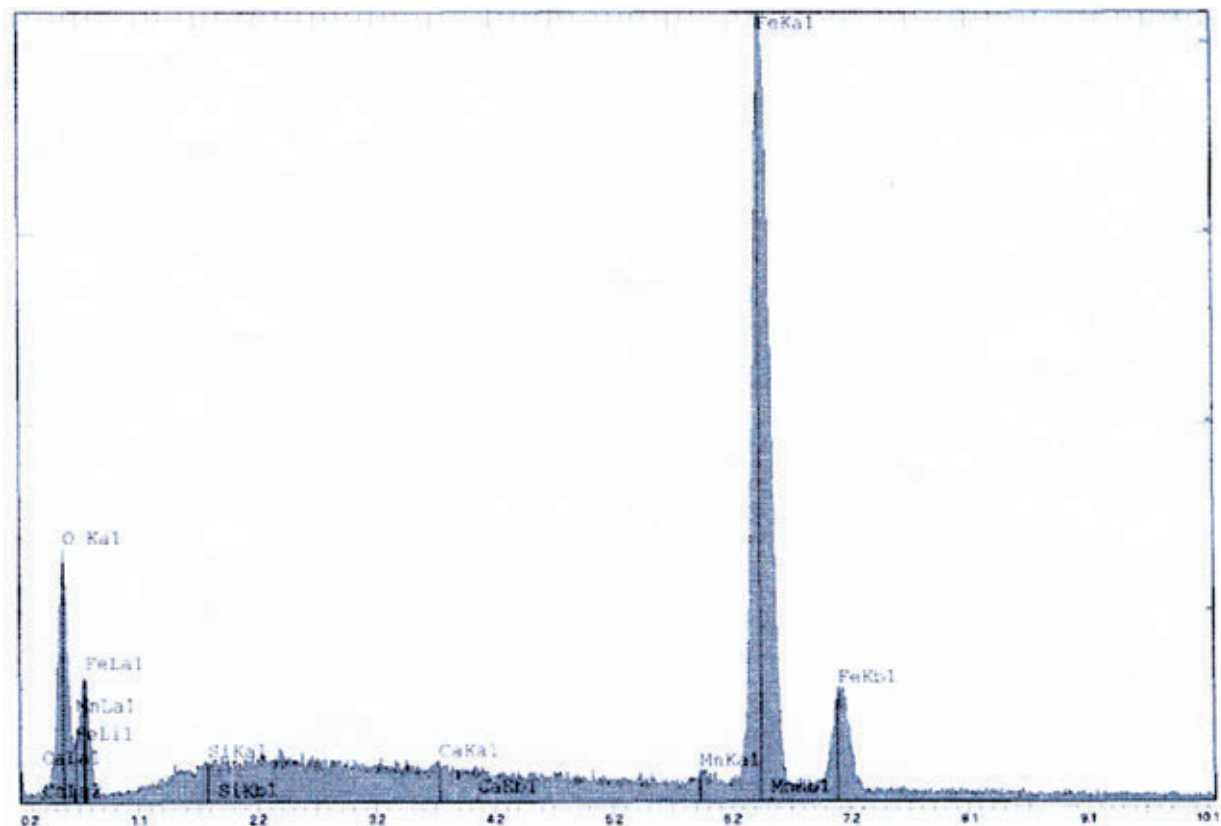
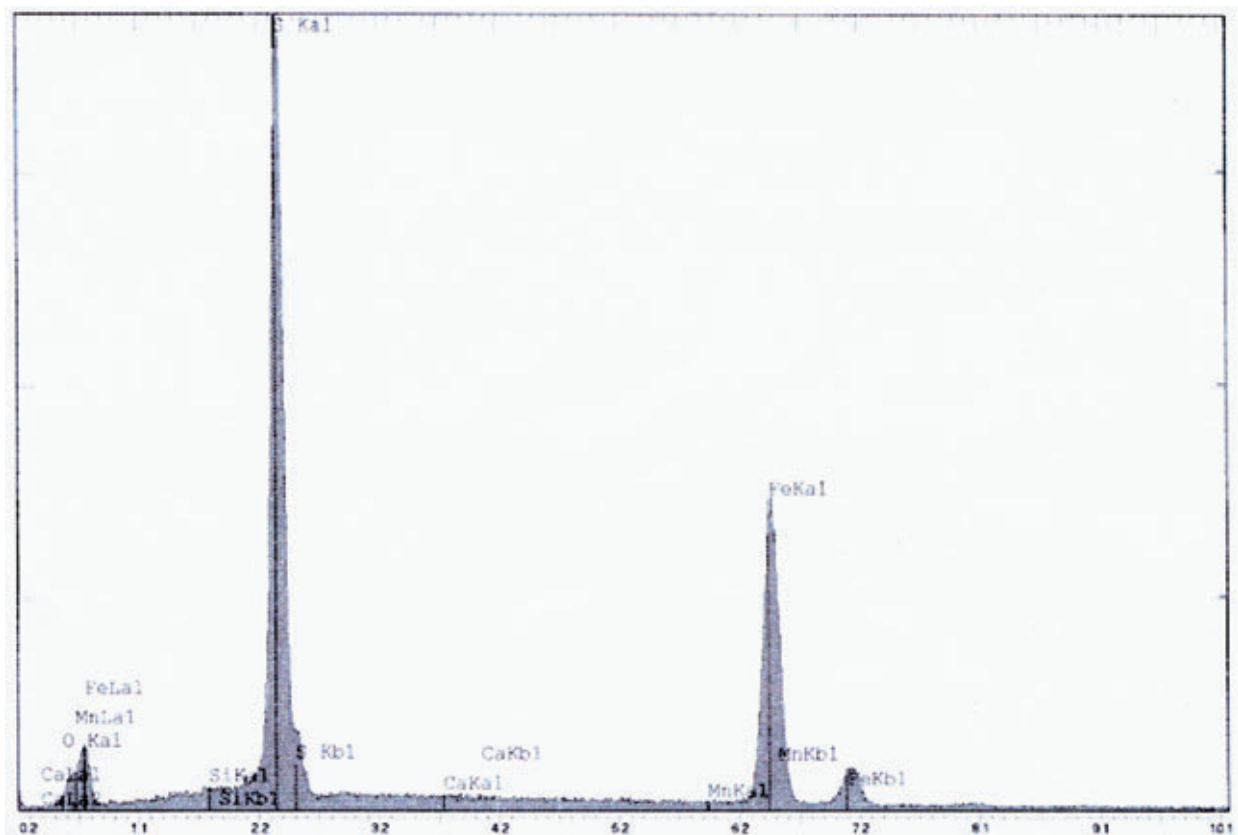
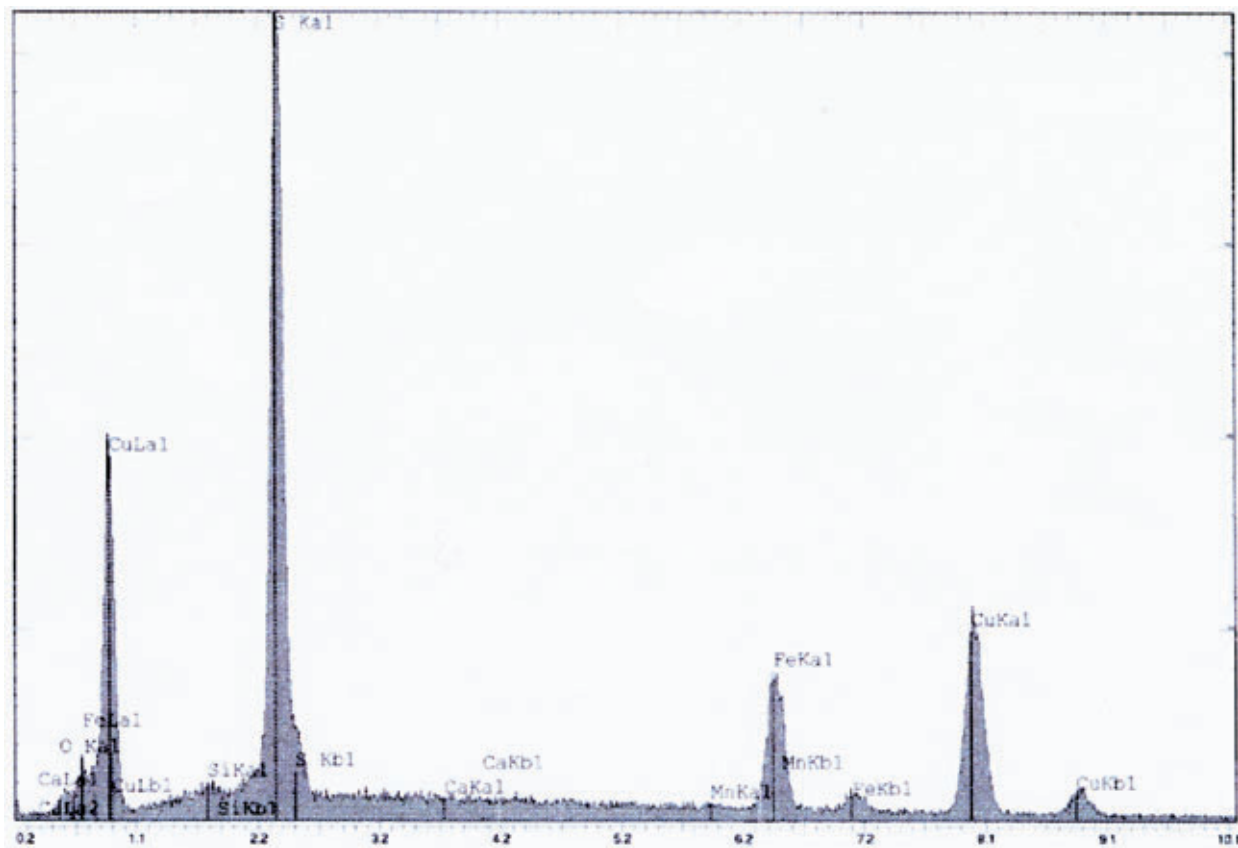
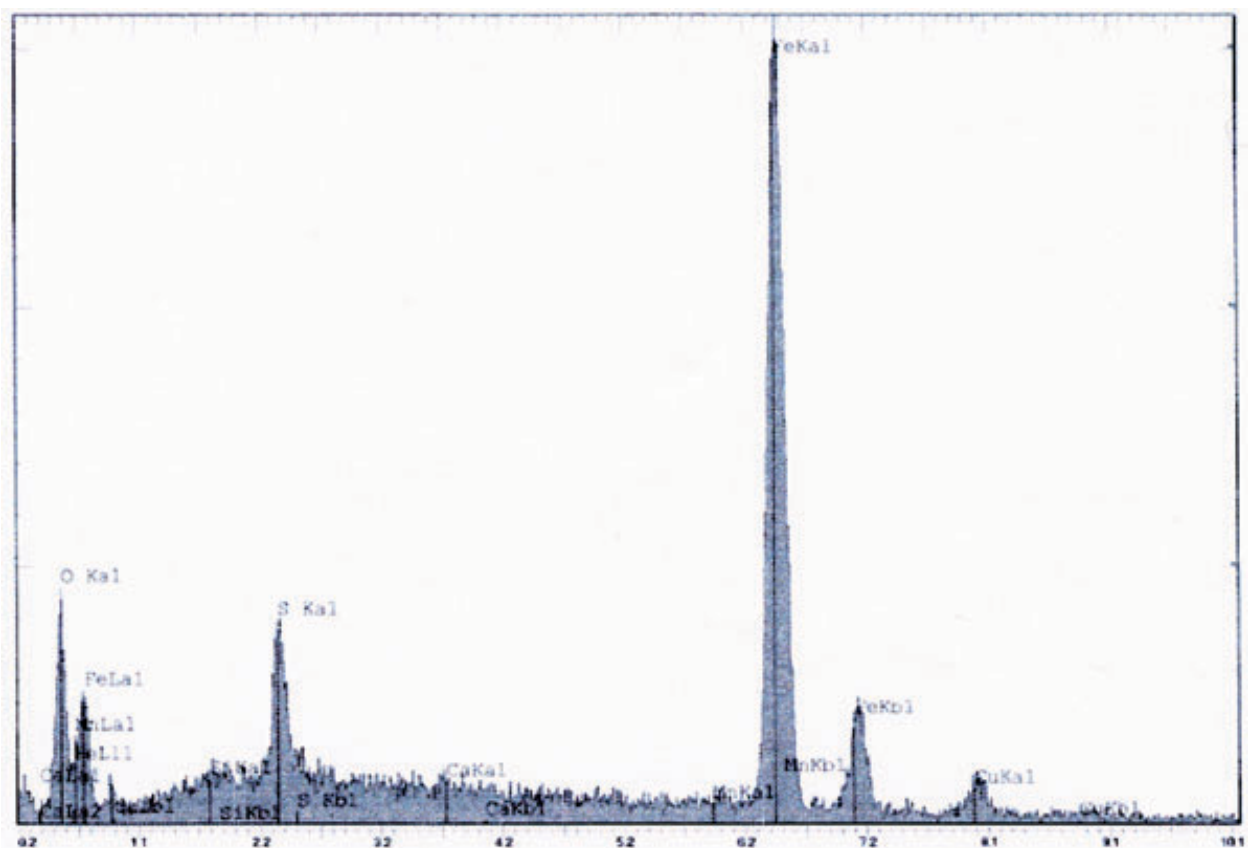
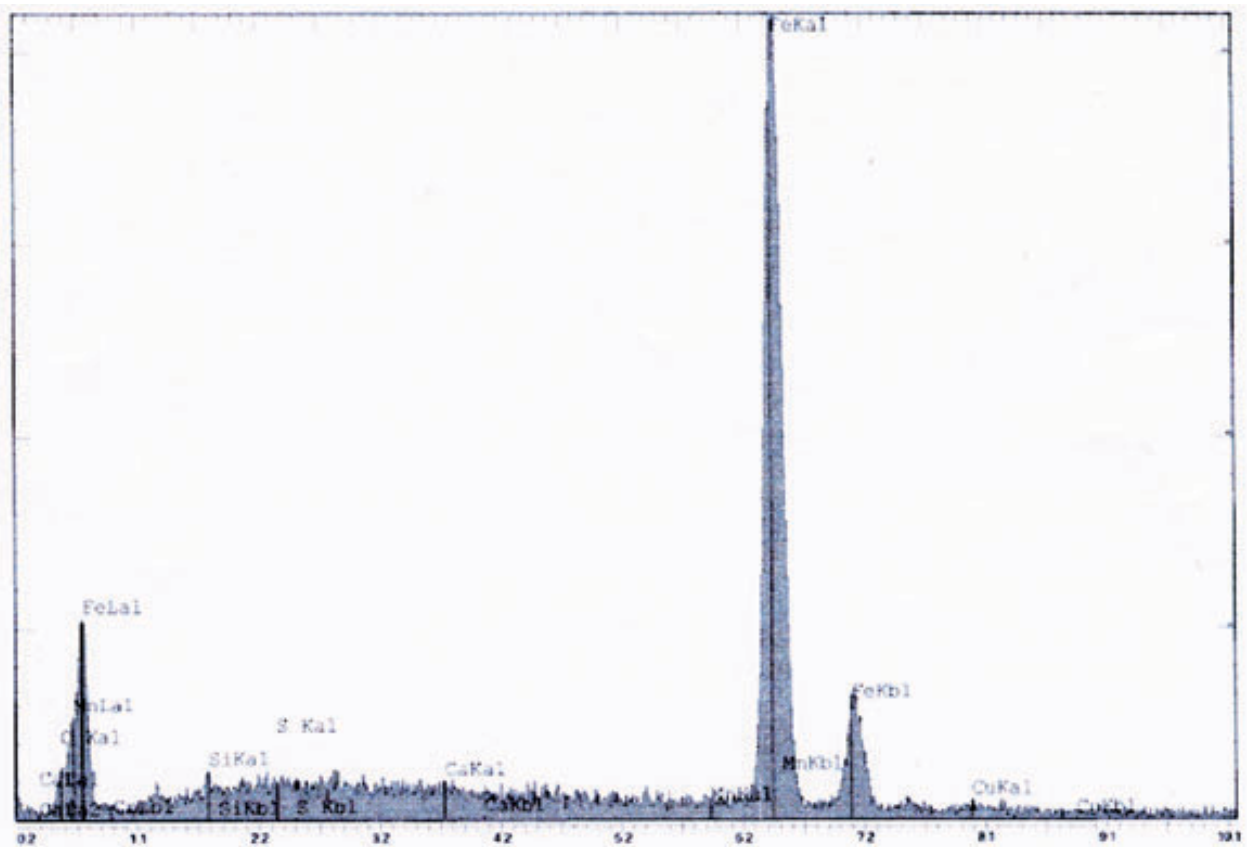
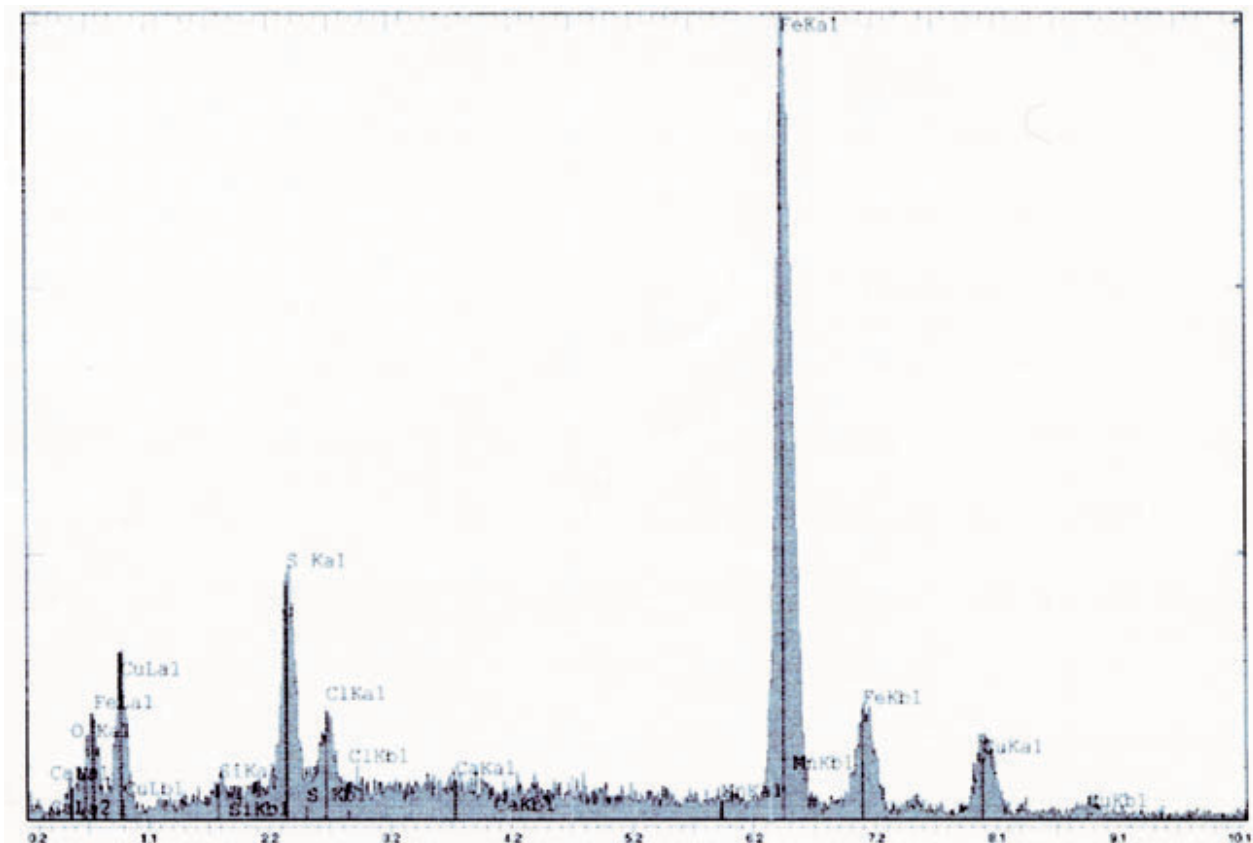
Figure C-13 Regions where chemical analysis was performed.

Figure C-13 shows the region where a qualitative chemical analysis of the eroded region was performed. The comparison of the EDX spectra from the specific regions identified in Figure C-13 shows concentration of copper and sulfur in the grain boundaries in addition to iron sulfide formation adjacent to iron oxide in the oxidized surface layer. Sulfide formation within the steel microstructure increases in concentration as the oxidized region is approached from the steel side. This is clearly shown in Figure C-14.

The larger sulfides further into the steel are the more stable manganese sulfides that were formed when the steel was made. The smaller sulfides that have formed as a result of the fire do not contain significant amounts of manganese, but rather are primarily sulfides containing iron and copper. These sulfides have a lower melting temperature range than manganese sulfide. It is much more difficult to tell if melting has occurred in the grain boundary regions in this steel as was observed in the A36 steel from WTC 7. It is possible and likely, however, that even if grain boundary melting did not occur, substantial penetration by a solid state diffusion mechanism would have occurred as evidenced by the high concentration of sulfides in the grain interiors near the oxide layer. Temperatures in this region of the steel were likely to be in the range of 700–800 °C (1,290–1,470 °F).

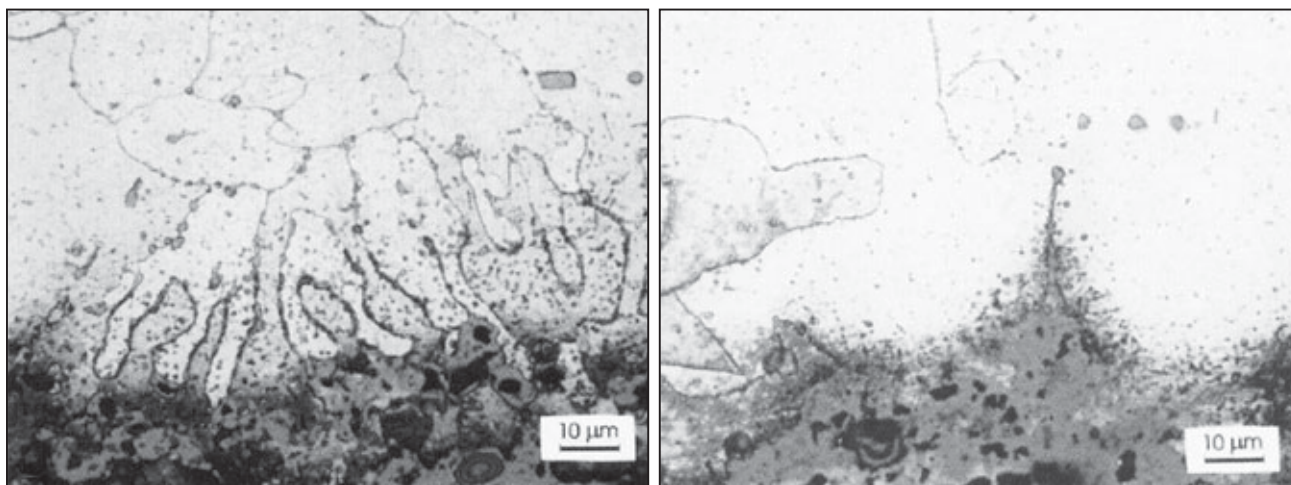
Figure C-14 Gradient of sulfides into the steel from the oxide-metal interface.
